# Debris/Ice/TPS Assessment And Photographic Analysis For Shuttle Mission STS-48

**Gregory N. Katnik**  
NASA/Kennedy Space Center

DEBRIS/ICE/TPS ASSESSMENT  
AND  
PHOTOGRAPHIC ANALYSIS  
OF  
SHUTTLE MISSION STS-48

September 12, 1991

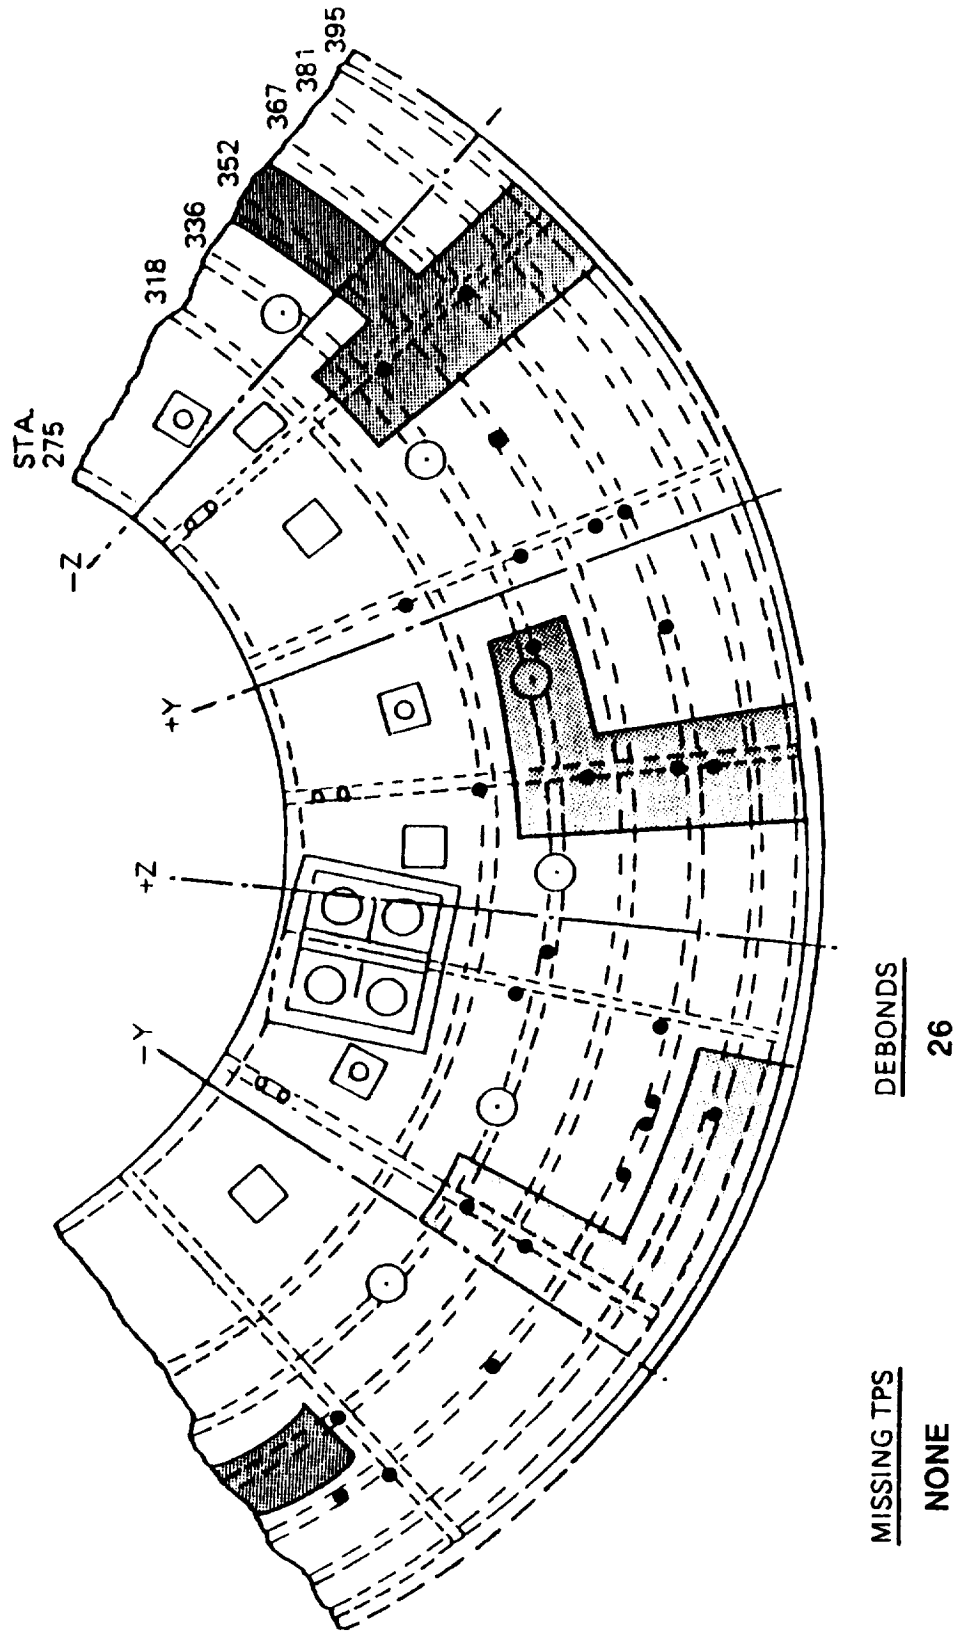
FIGURE 5. RIGHT SRB FRUSTUM

The RH frustum had no areas of missing TPS but had 26 MSA-2 debonds over fasteners. There was minor localized blistering of the Hypalon paint (Figure 5). All BSM covers were locked in the fully opened position.

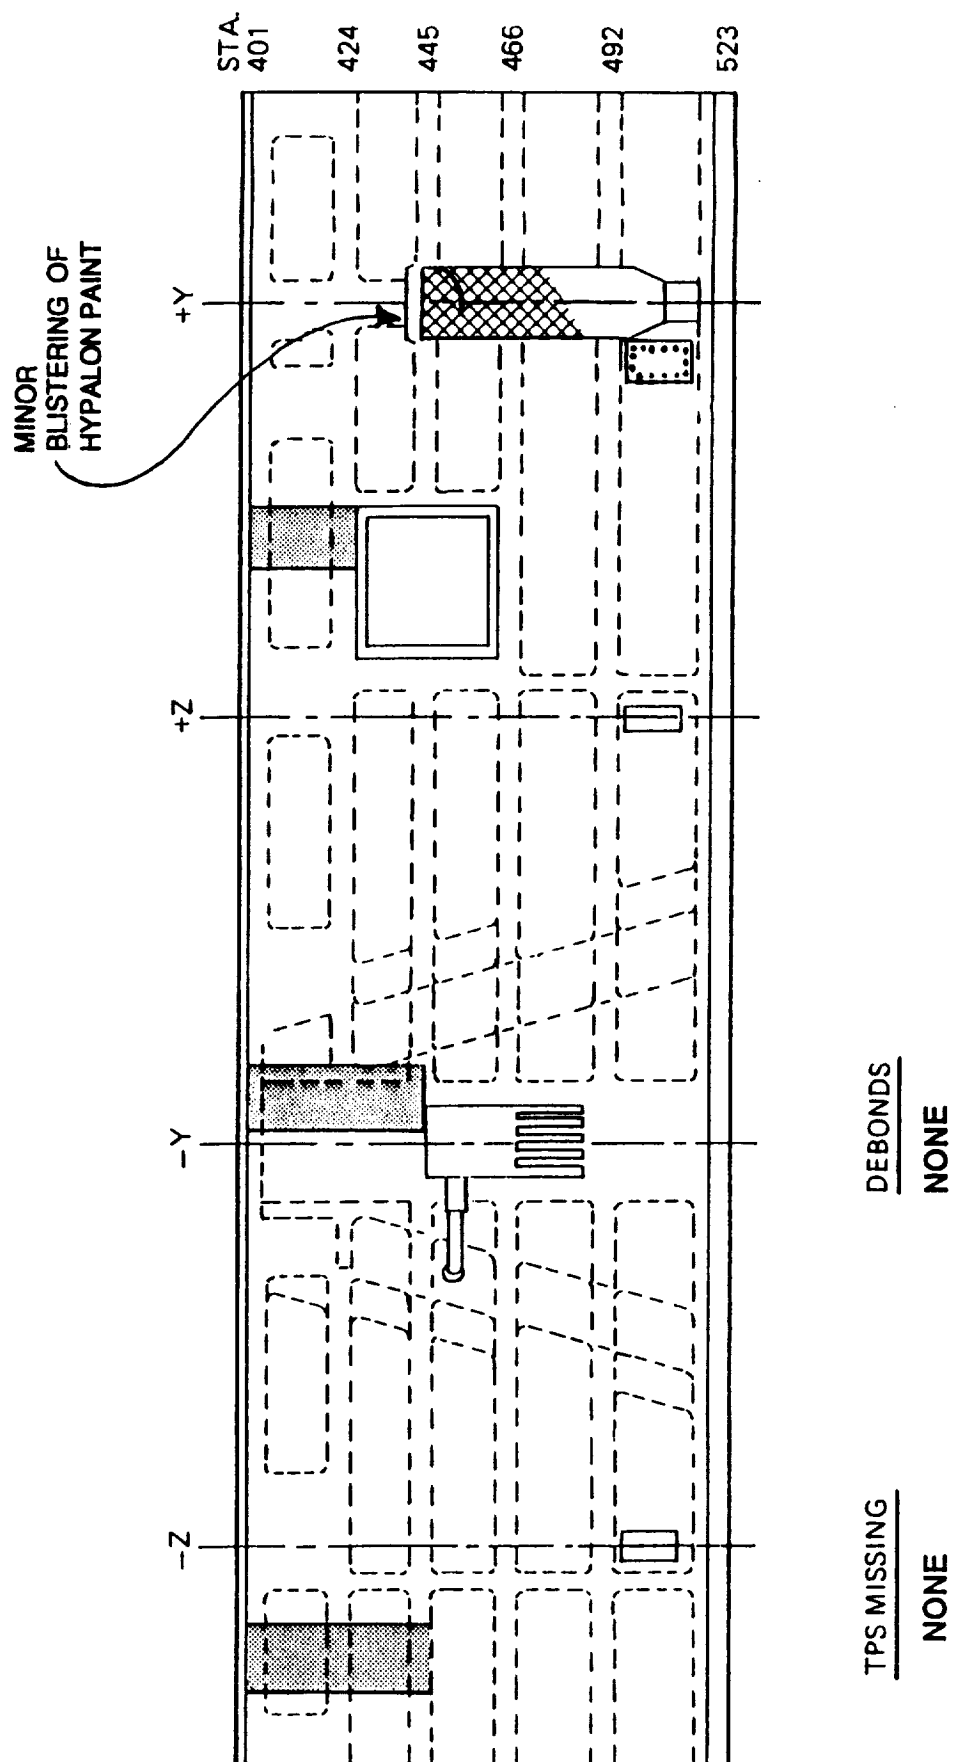
FIGURE 6. RIGHT SRB FWD SKIRT

The RH forward skirt exhibited no debonds or missing TPS. The phenolic plates on both RSS antennae were intact. The forward separation bolt and electrical cables appeared to have separated cleanly. No pins were missing from the frustum severance ring. Minor blistering of the Hypalon paint occurred forward of the ET/SRB attach point (Figure 6).

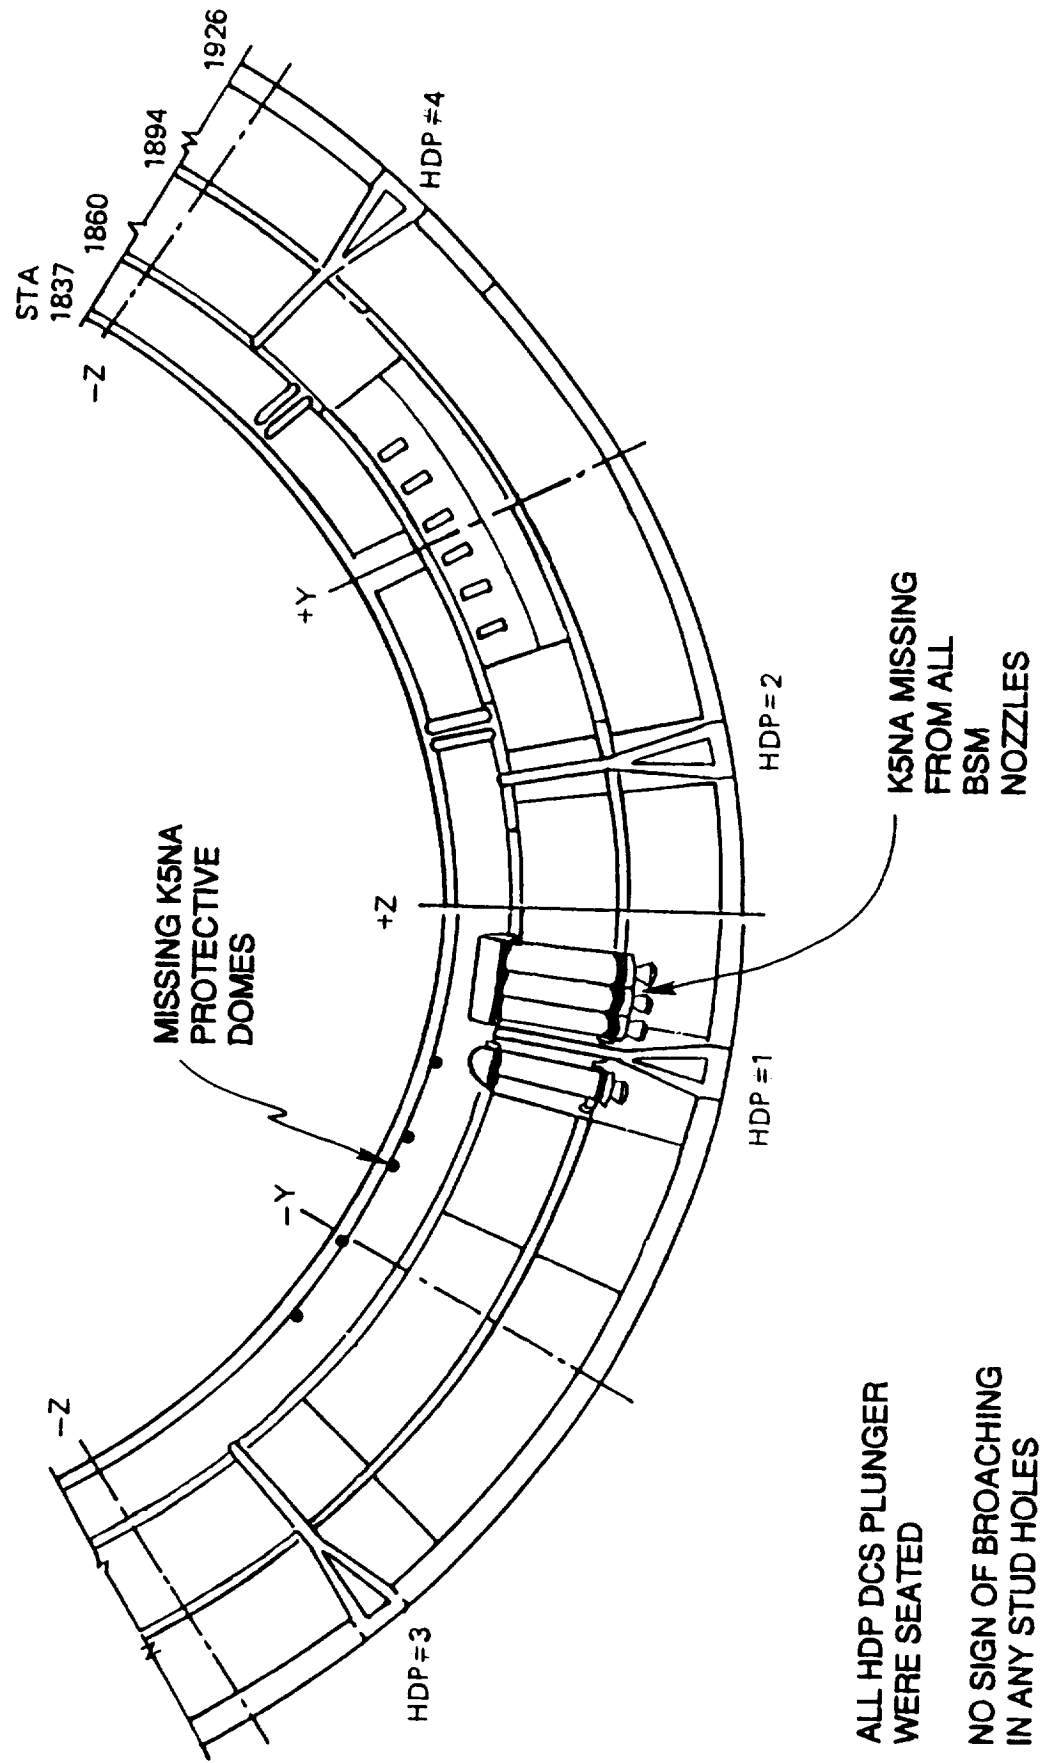
FIGURE 7. RIGHT SRB AFT SKIRT EXTERIOR TPS

The phenolic material on the kick ring was delaminated. Five K5NA protective domes between HDP #1 and #3 were lost from bolt heads on the aft side of the phenolic kick ring prior to water impact (sooted substrate). The aft skirt acreage TPS was in good condition (Figure 7). K5NA was missing from all aft BSM nozzles.

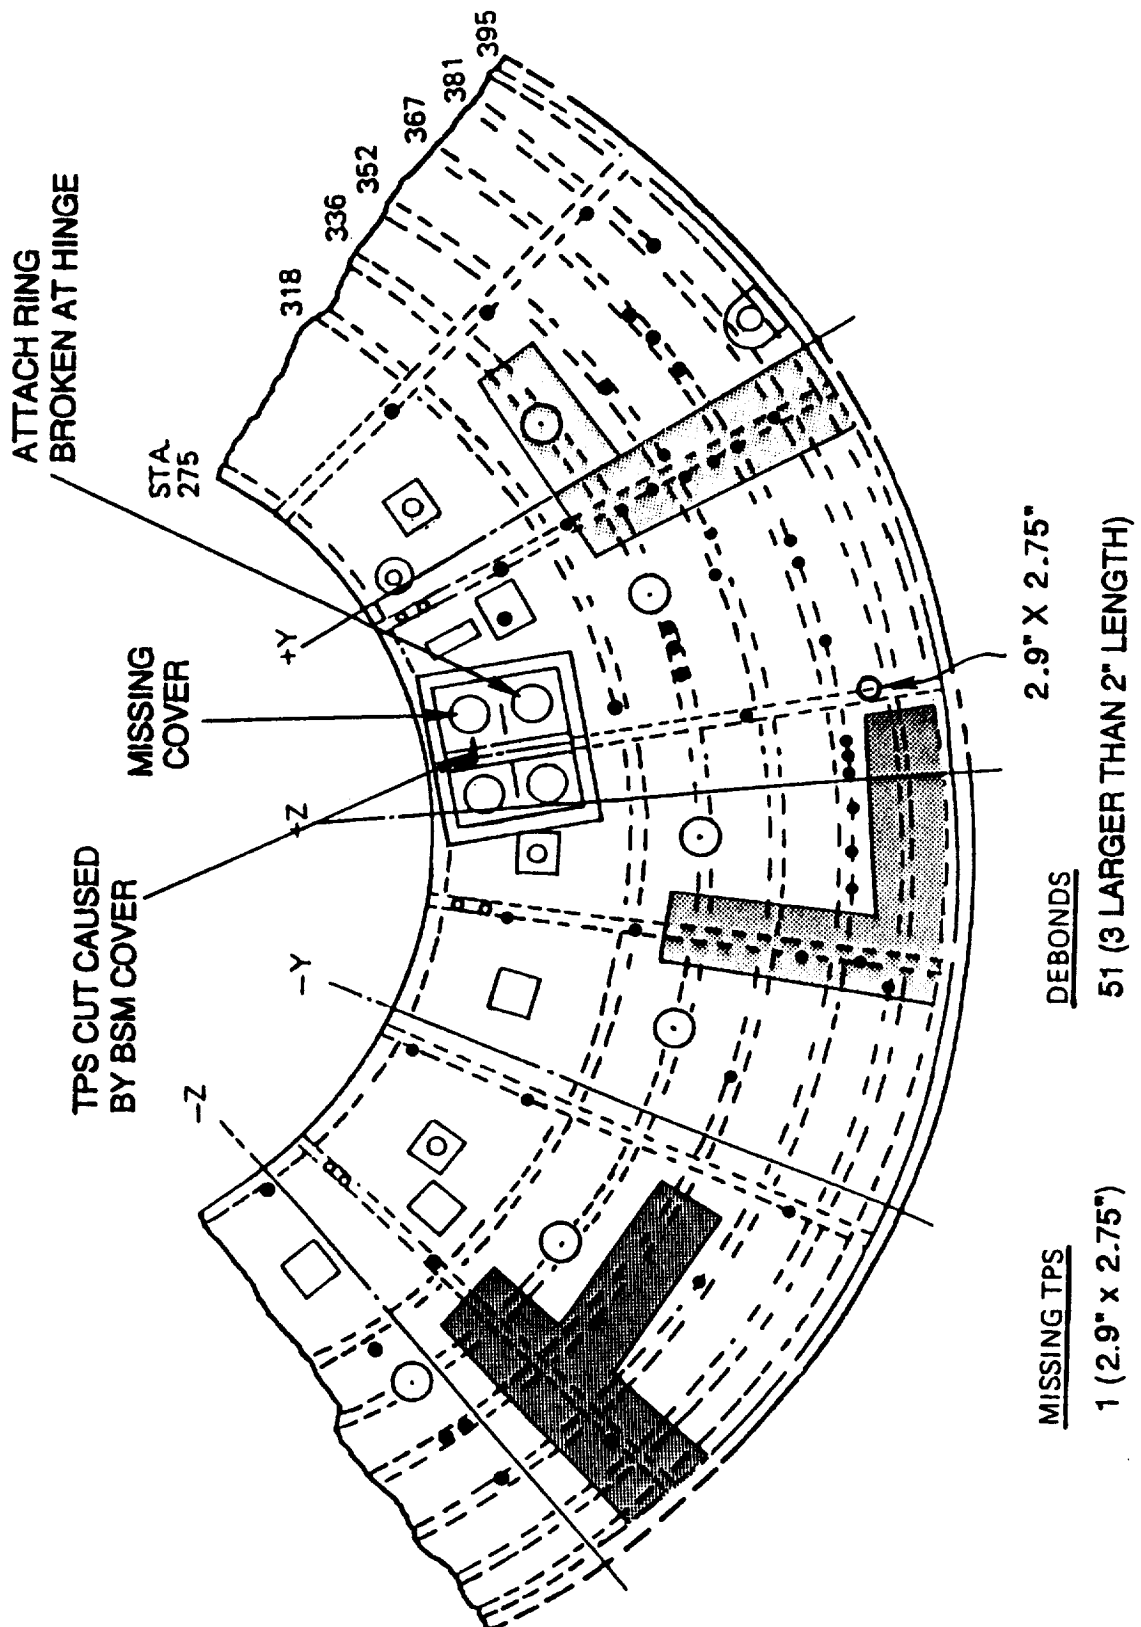
FIGURE 8. LEFT SRB FRUSTUM

The LH frustum had 51 MSA-2 debonds over fasteners (Figure 8). A 2.9"x2.75" area of MSA-2 was missing from two fasteners on the stiffener below the BSM's near the 381 ring. The MSA-2 had separated completely from the substrate. The MSA-2 fracture edges and surrounding Hypalon paint were not sooted/charred, the exposed MSA-2 material was clean, and no unusual heating effects were visible. Samples were taken for laboratory analysis at MSFC. There was minor localized blistering of the Hypalon paint on the acreage areas of the frustum.

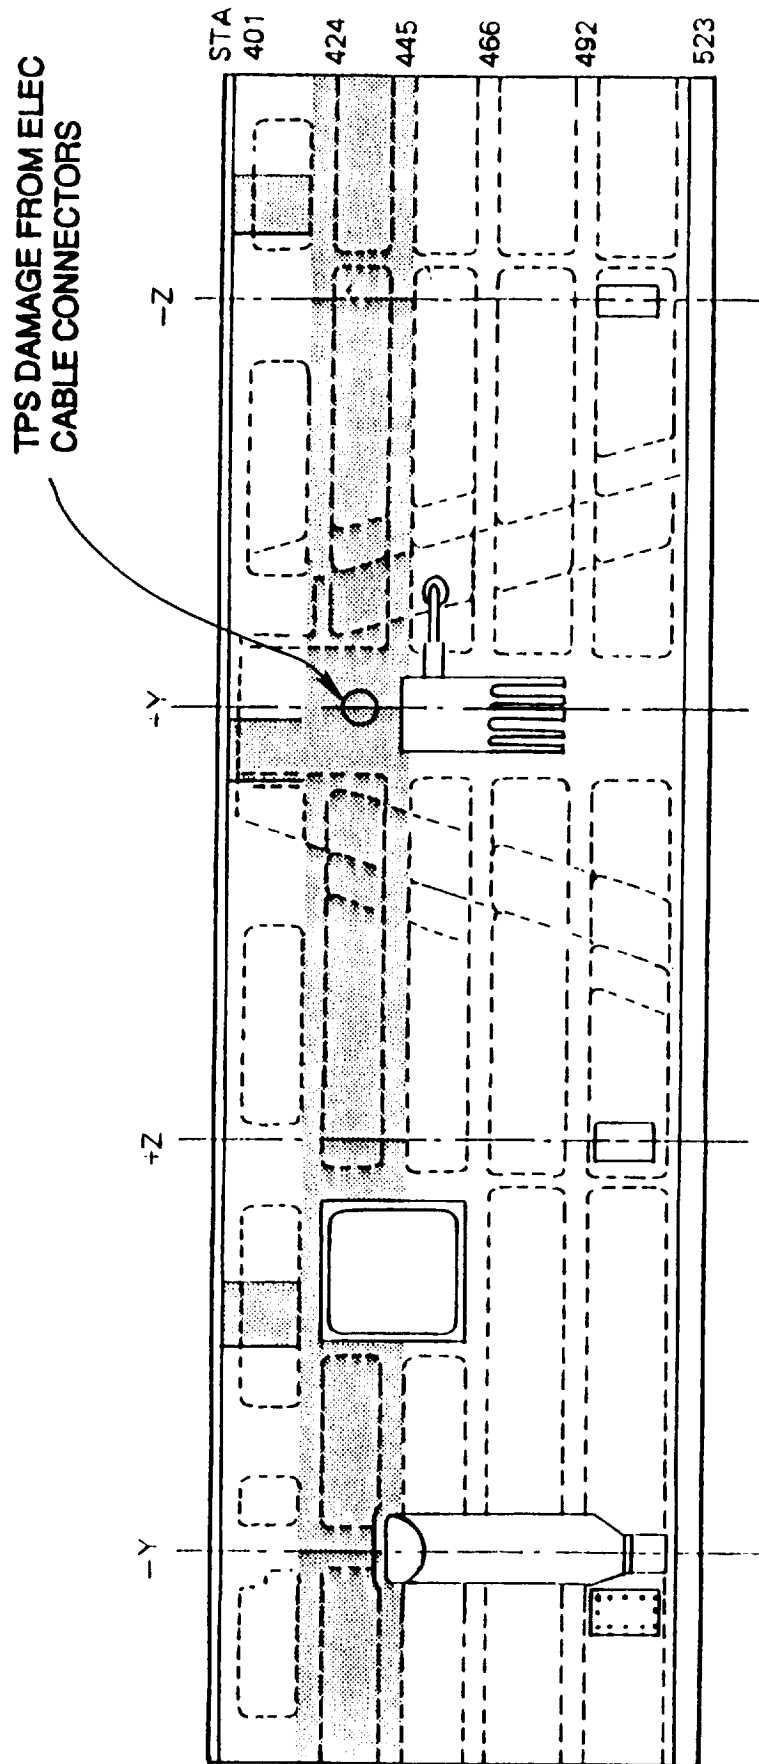
FIGURE 9. LEFT SRB FWD SKIRT

The LH forward skirt exhibited no debonds or missing TPS. The phenolic plates on both RSS antennae were intact. The forward separation bolt and electrical cables appeared to have separated cleanly. No pins were missing from the frustum severance ring. Minor blistering of the Hypalon paint occurred forward of the ET/SRB attach point (Figure 9).

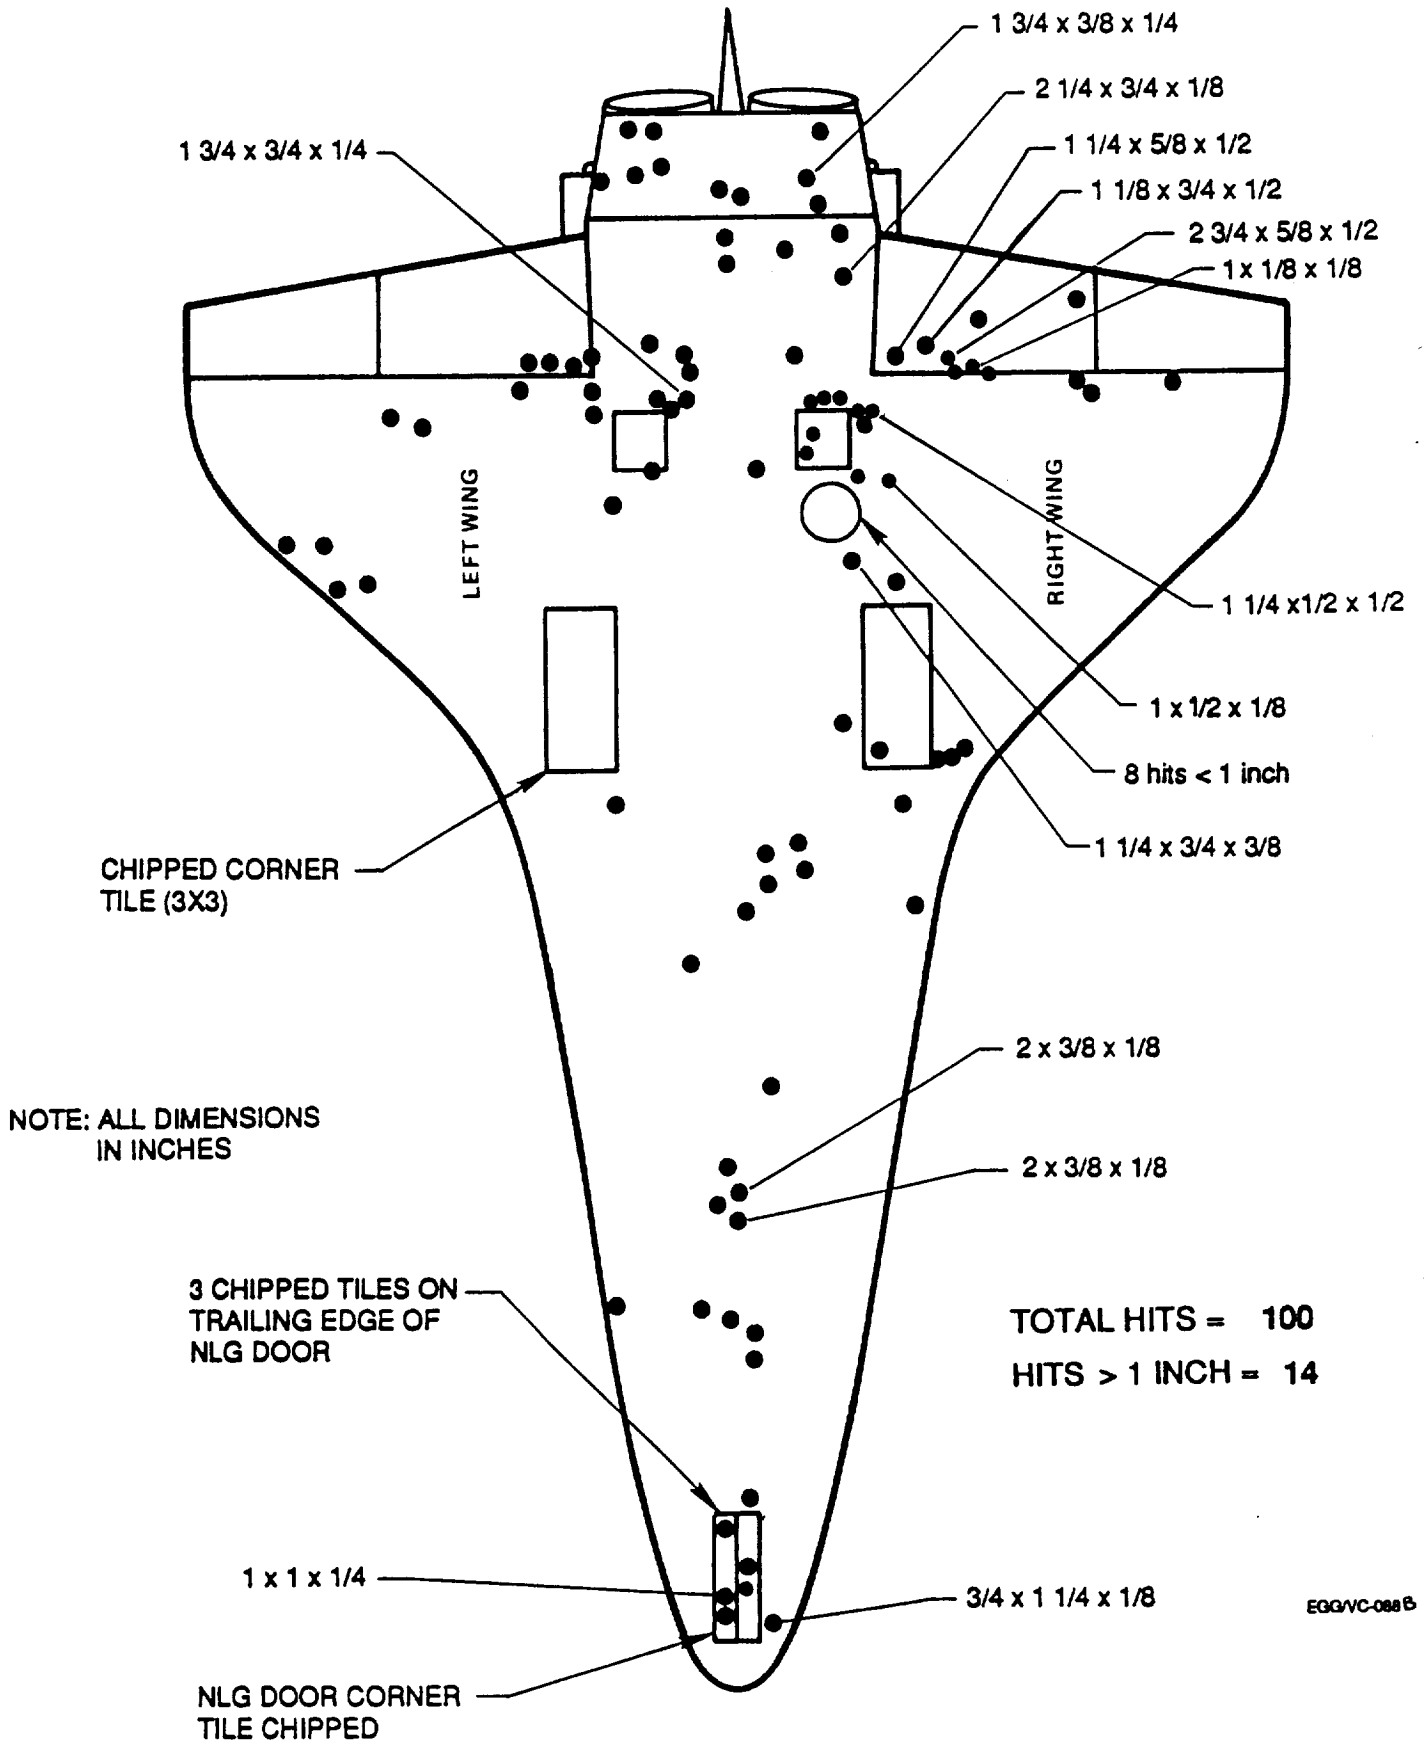
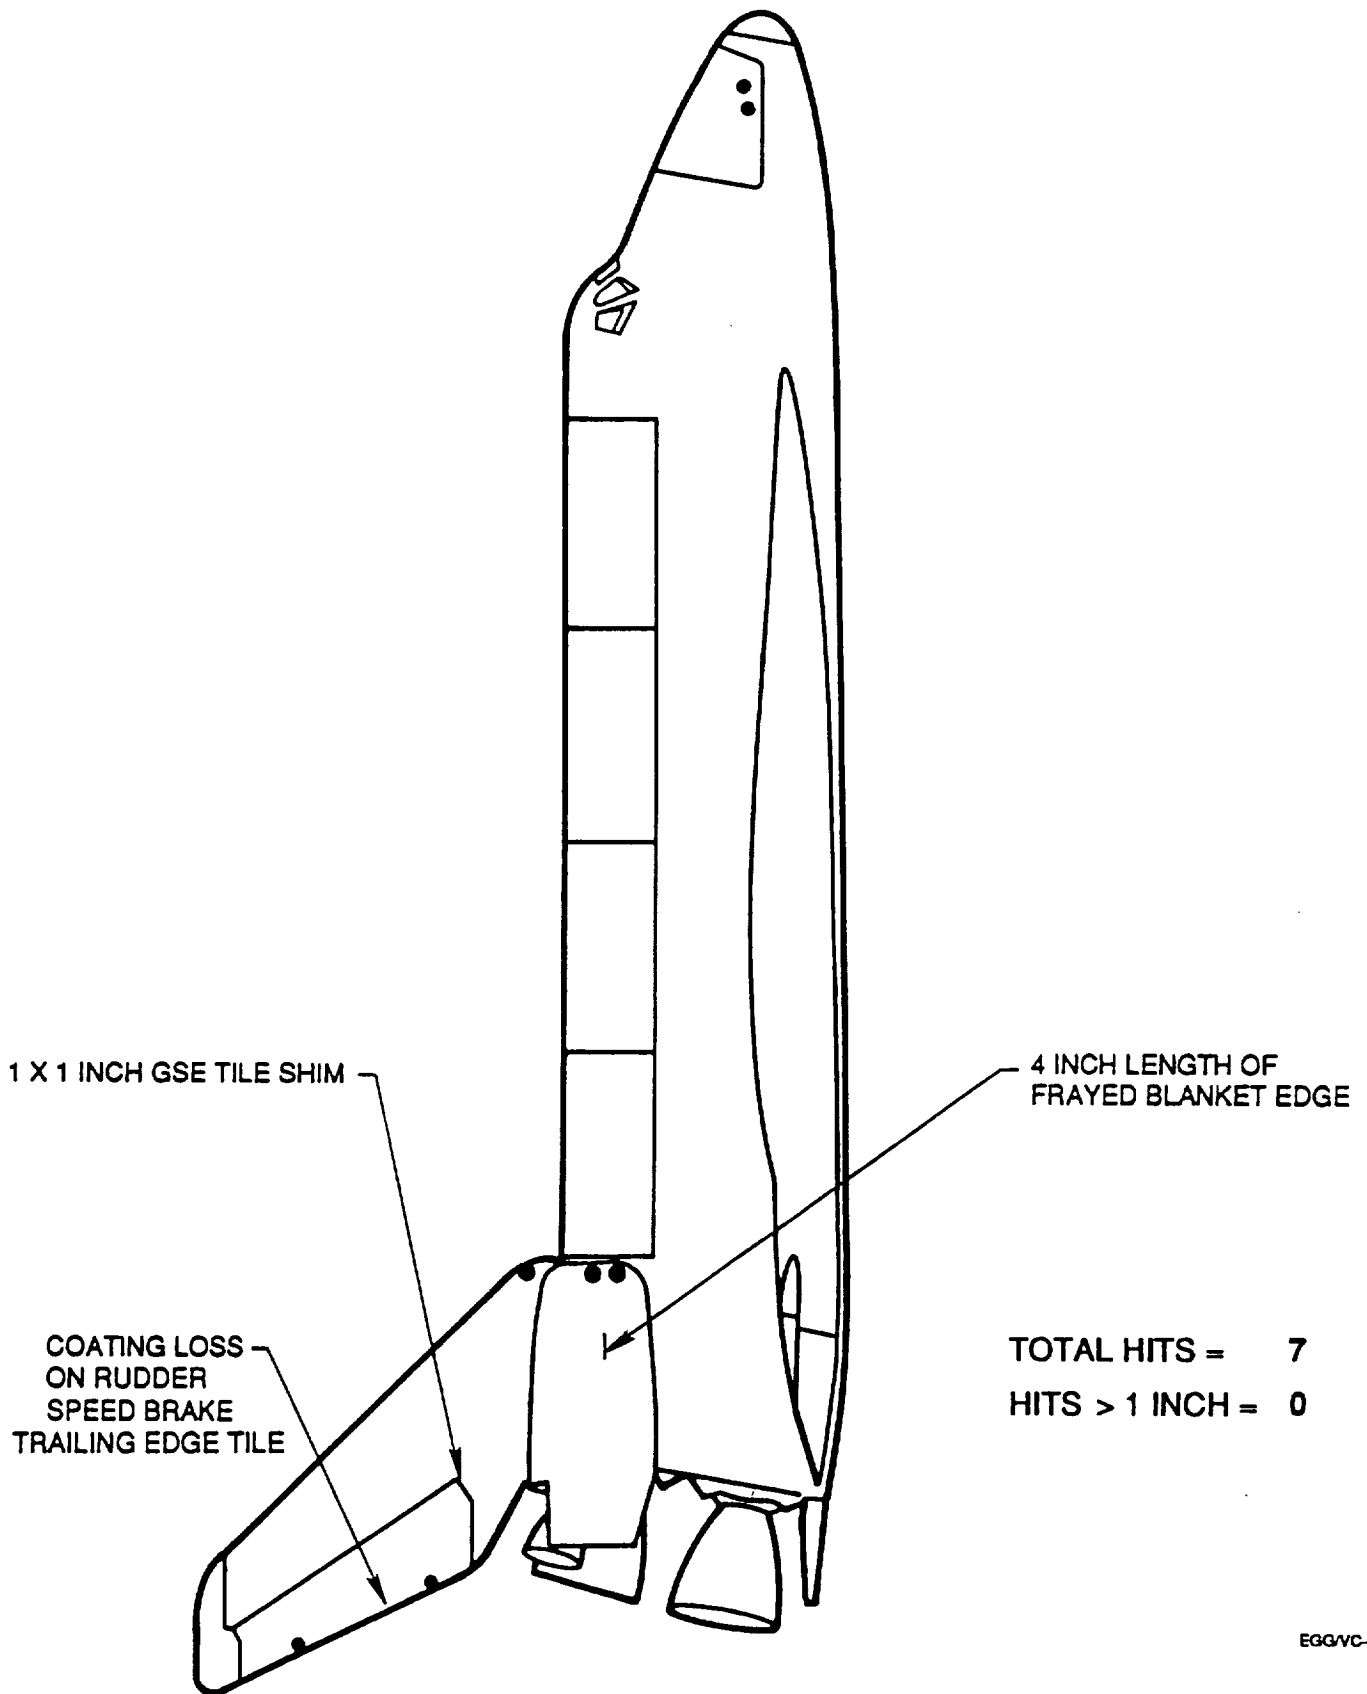
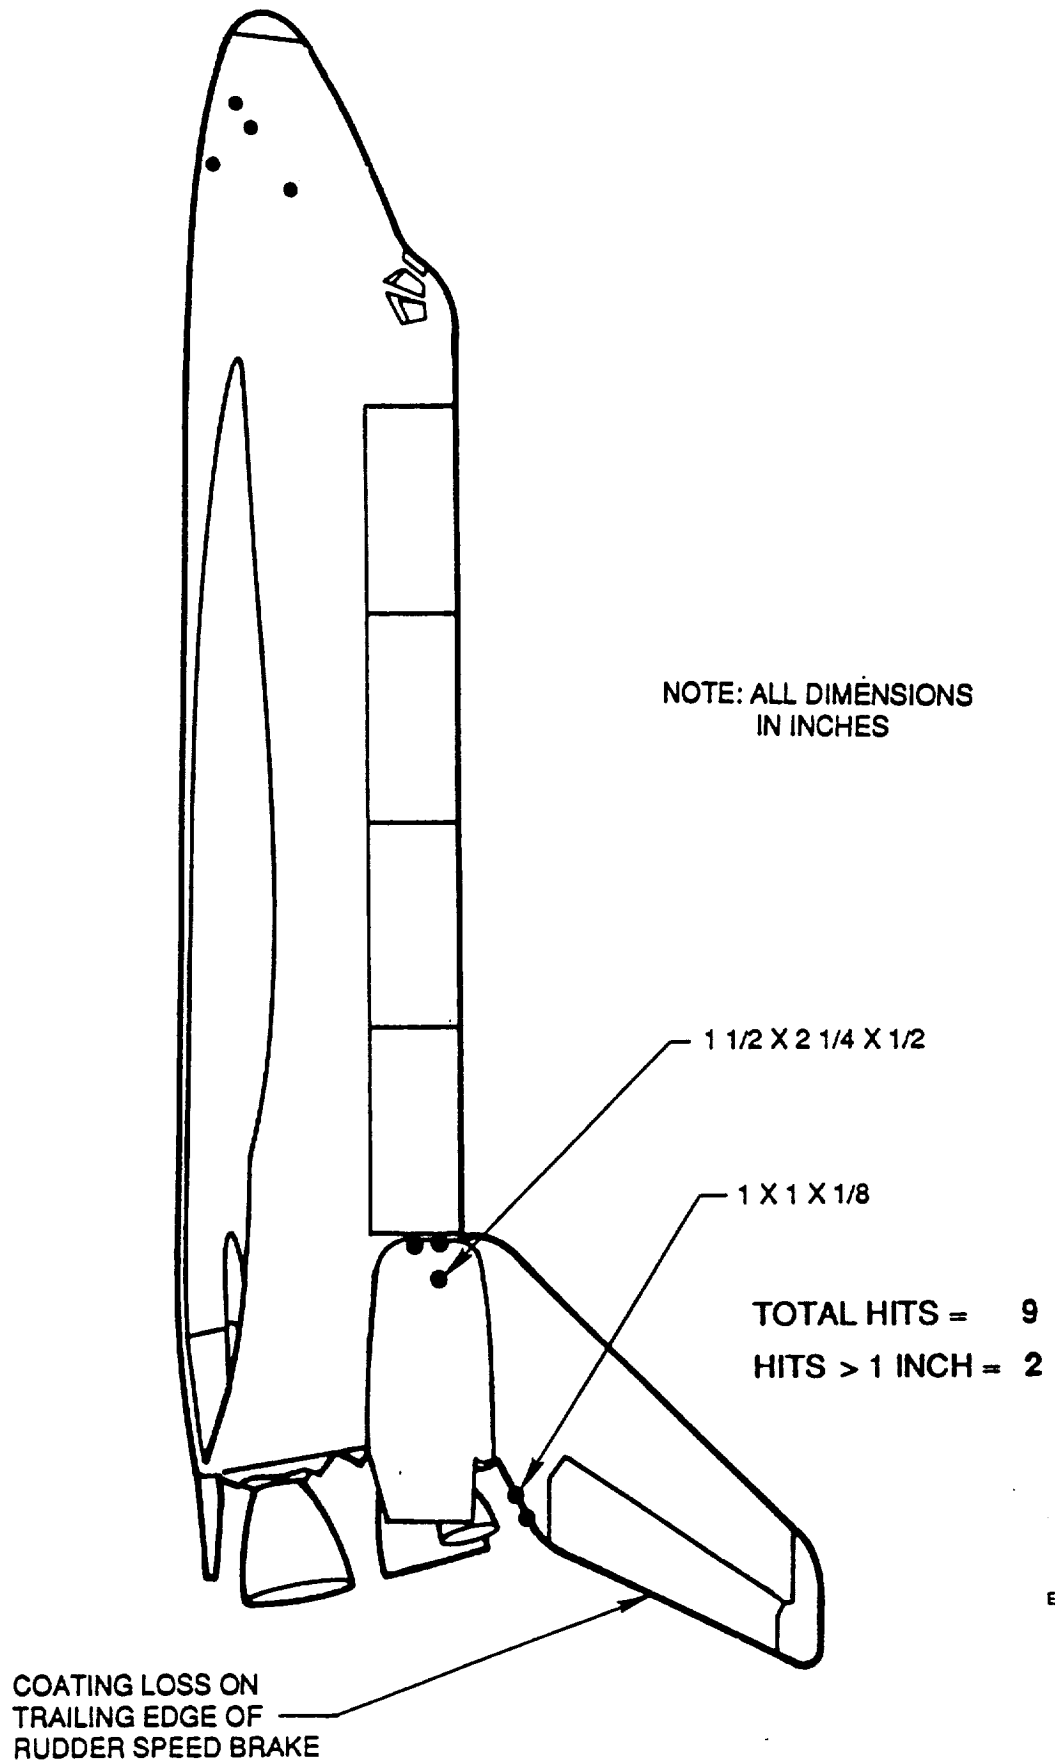
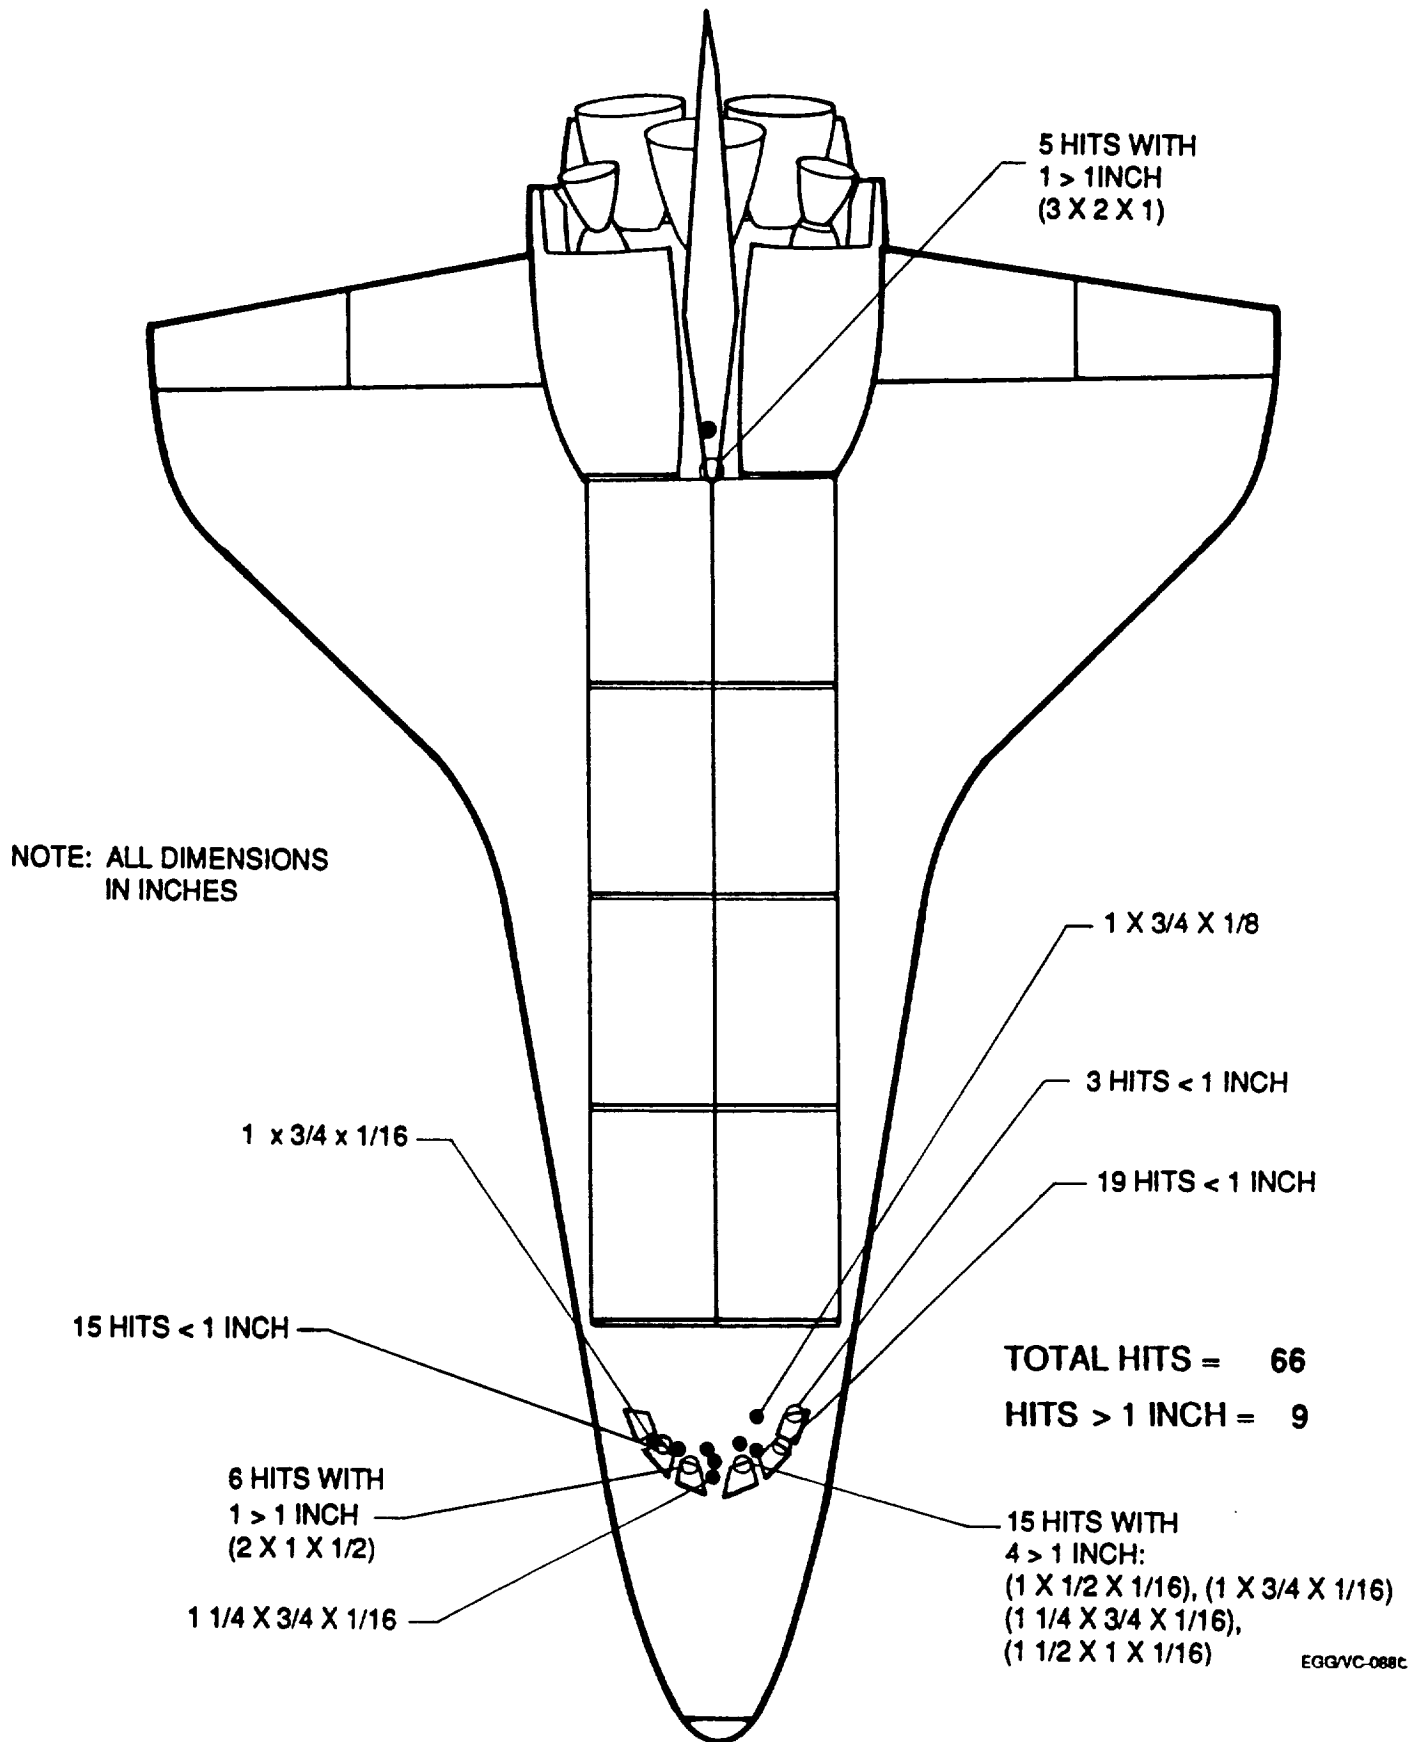
The Orbiter lower surface had a total of 100 hits of which 14 had a major dimension of one inch or greater. A comparison of these numbers to statistics from 30 previous missions of similar configuration (excluding missions STS-24, 25, 26, 26R, 27R, and 30R which had damage from known debris sources), indicates that the total number of hits was slightly greater than average and the number of hits one inch or larger was slightly less than average. Figures 11 - 14 map the TPS debris damage for STS-48.

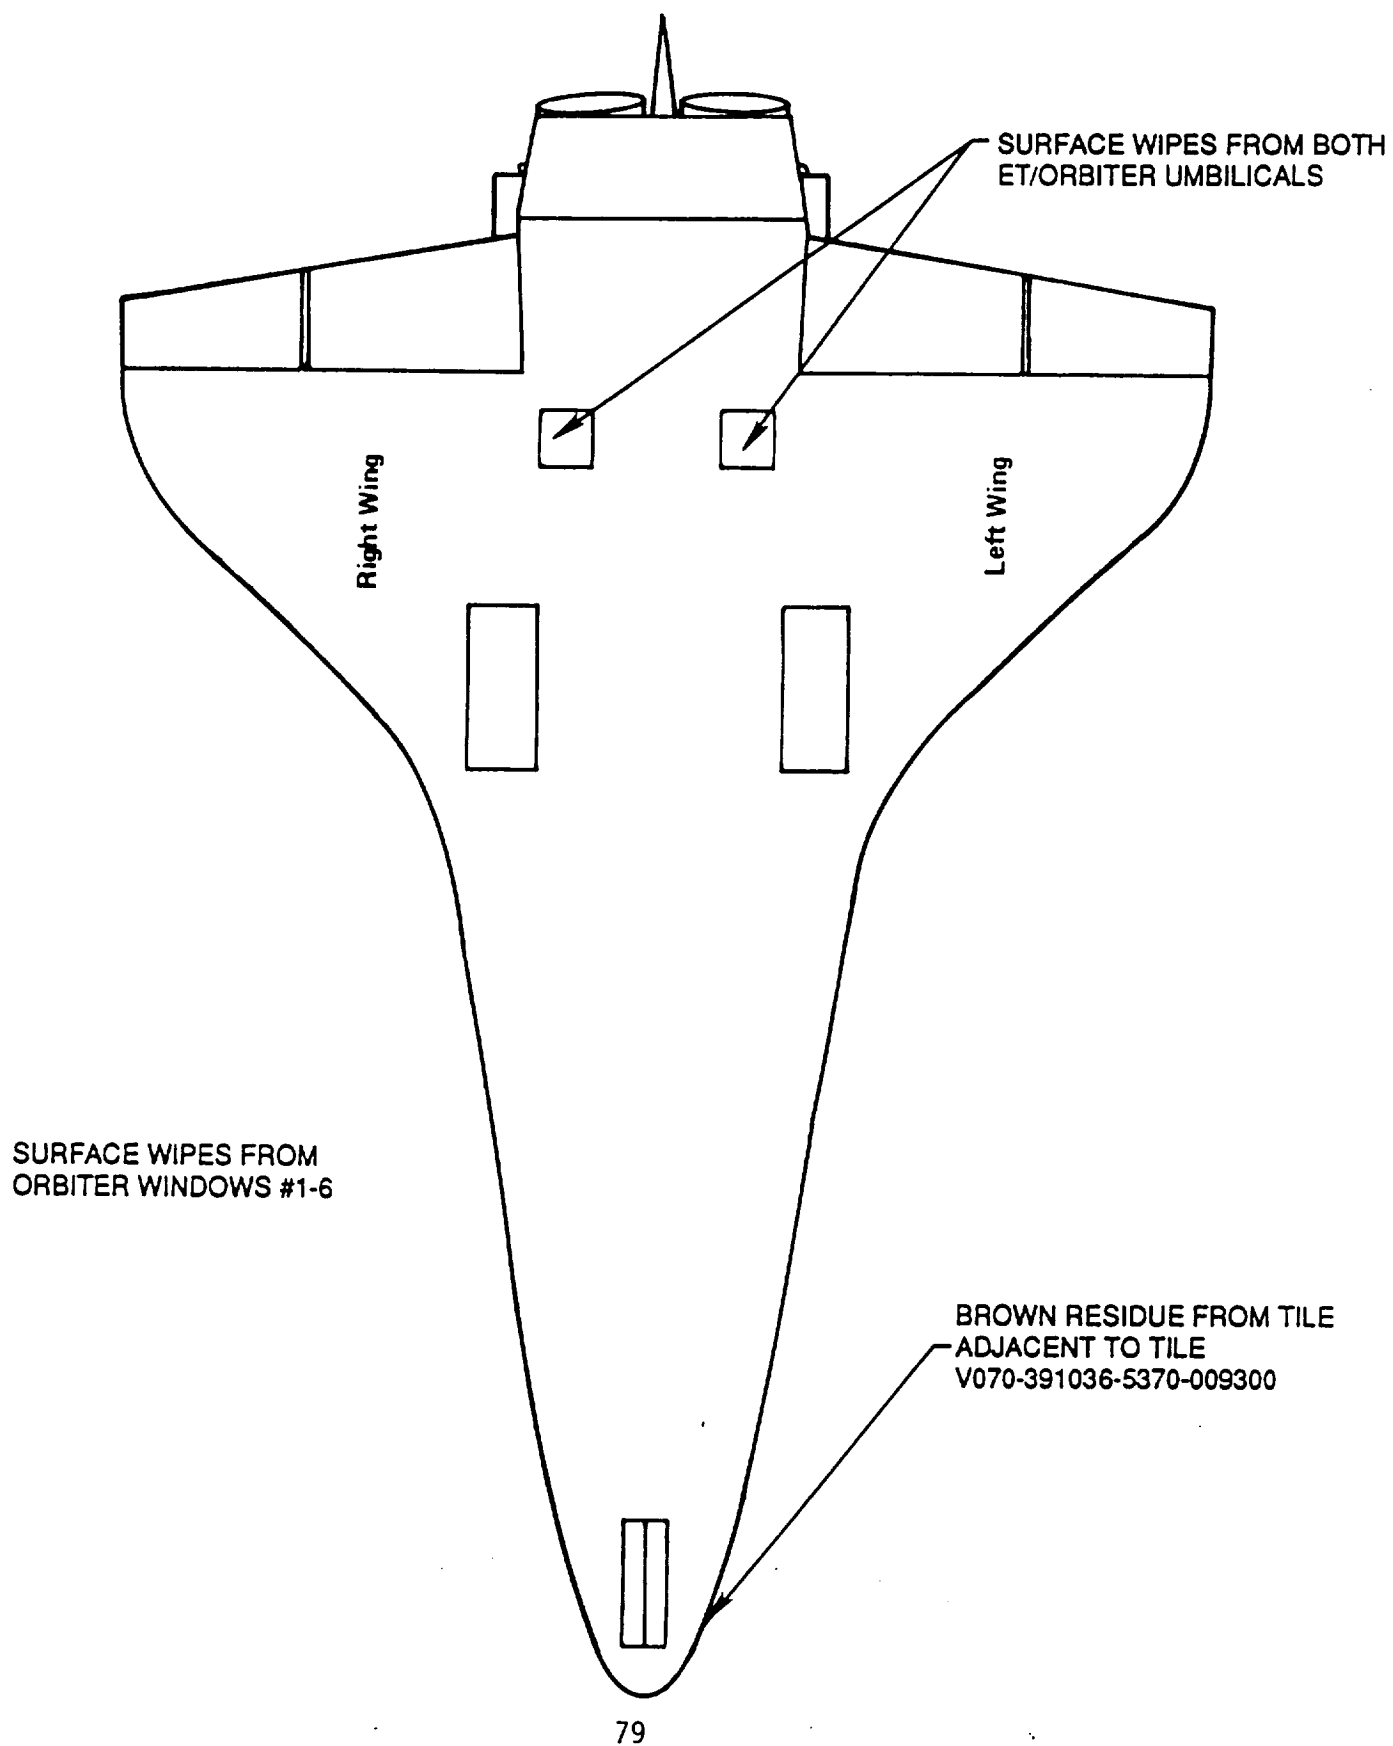
FIGURE 15.  
**STS-48 DEBRIS DAMAGE CHEMICAL SAMPLE LOCATIONS**

Orbiter windows #1, #2, #5, & #6 were lightly hazed. Windows #3 and #4 exhibited moderate to heavy hazing and had numerous streaks. Laboratory analysis was performed on samples taken from all windows (reference Figure 15 and Section 9.0).

A total of 13 samples were obtained from Orbiter OV-103 during the STS-48 post landing debris assessment at Ames-Dryden Flight Research Facility (ADFRF), California (Figure 15). The 13 submitted samples consisted of 8 Orbiter window wipes (W1-8), 1 tile residue sample, and 4 samples from the LOX and LH2 ET/Orbiter umbilicals. The samples were analyzed by the NASA KSC Microchemical Analysis Branch (MAB) for material composition and comparison to known STS materials. Debris analysis involves the placing and correlating of particles with respect to composition, thermal (mission) effects, and availability. Debris sample results and analyses are listed by Orbiter location in the following summaries.
